2022 Annual Facilities Inspection Report

Hackettstown Municipal Utilities Authority

December 2022

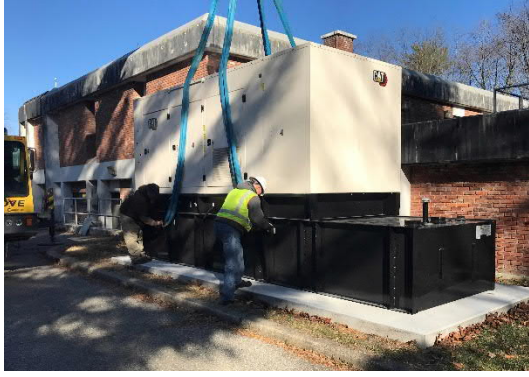
New Generator

In October 2021, it was noted the site generator would be replaced, as the current generator was beyond repair.

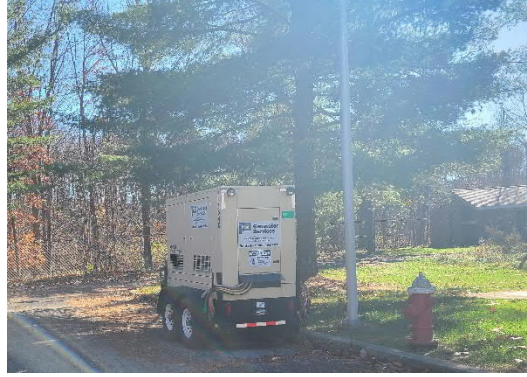
Temporary Generator

During the November 2022 inspection, an external temporary generator had been installed at the site outside of the building. A new outdoor pad and conduits to the automatic transfer switch in the Generator room were installed, awaiting the replacement generator. The new generator arrived on 11/28/2022. The external contact tanks at the site were partially filled with water, and should be drained. The damage to the fence previously noted during 2021 has not been repaired. A leak was found near a window inside the site, it was noted to be an ongoing leak for approximately 6 months.

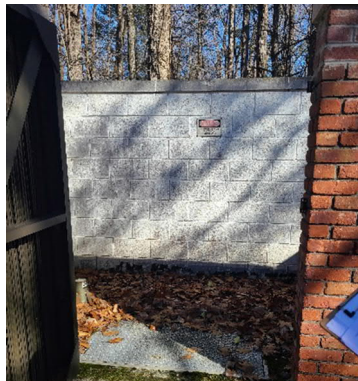
The HMUA received bids for Contract 35W in January 2008 to rehabilitate the well pumps for Well No. 5 to restore the pumping capacity to 1,000 GPM. Minor masonry damage at Well No. 5 as noted during previous inspections was repaired in 2016. Controls for Well No. 5 are housed in the Well No. 4 building. The pressure relief valve was replaced during 2021. During the December 2022 inspection, Well No. 5 was noted to be in good condition.

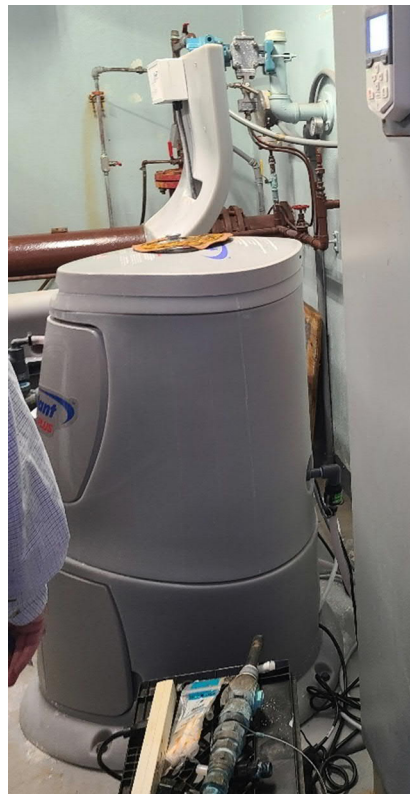
Chlorine Tab System

During the November 2022 inspection, it was noted that the planned pilot study for the chlorine tab equipment had been run, following the pump VFD replacement in May 2022. It was noted that due to the time and labor required for the manufacturer to remove the pilot equipment, the manufacturer has given the HMUA the chlorine tab equipment. The HMUA is planning to try accu-tabs with the Constant Chlor equipment to see if this will generate better results. It was reported that the dehumidifier is working well.

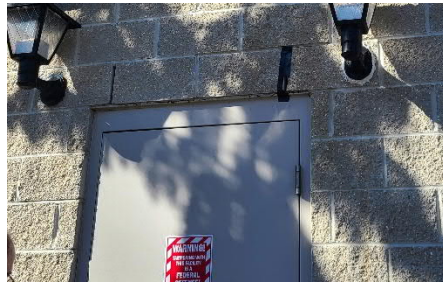
During the 2022 inspection, it was noted that yellow jackets are living directly above the entry door to the well building. The HMUA has made multiple attempts to remove the yellow jacket nest but has not removed them yet.

Yellowjacket entry to nest above door – duct tape

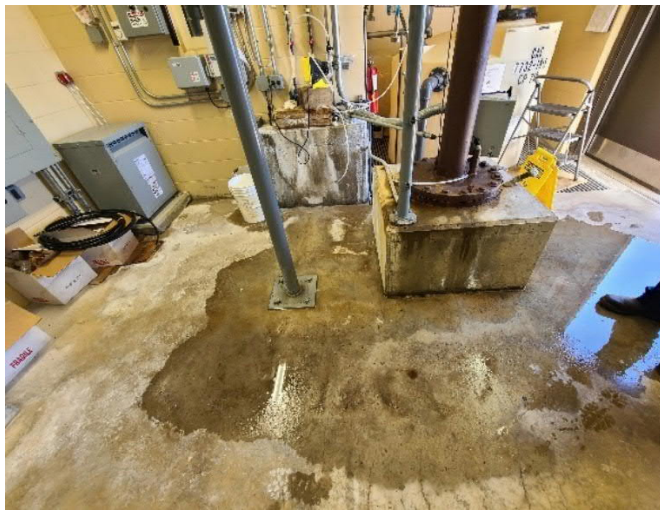
Well No. 9 – Condensate

Well No. 9 - Heath		
2022 Findings by Mott MacDonald	Ongoing Issues / Items to be Addressed	Items addressed / Completed Upgrades in 2021-2022
<p>Floor of the Well House was wet due to a sample taken earlier in the day and lack of a floor drain.</p> <p>Currently Well No. 9 is the only well adding ortho-phosphate to the system.</p>	n/a	Dosing pump has been replaced.

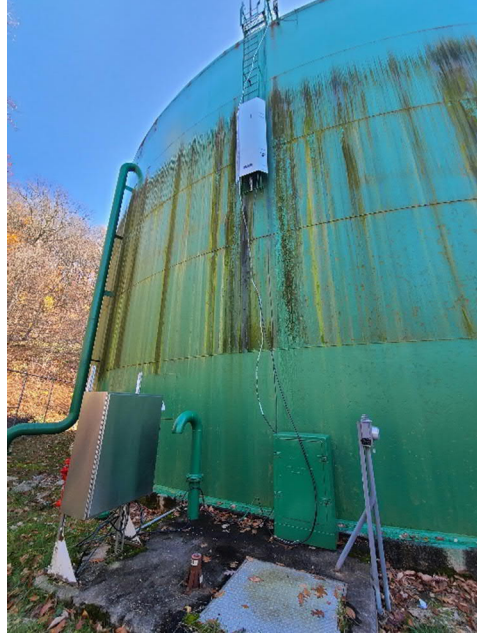
- 2021 – Growth was still noted on the exterior of the tank. The antenna was struck by lightning, and a partial replacement of the antenna was required. The grass around the tank has been maintained.
- 2022 – Growth was noted on the exterior of the tank. Tank appears to be in good condition.

2.4 MG Water Storage Tank		
2022 Findings by Mott MacDonald	Ongoing Issues / Items to be Addressed	Items addressed / Completed Upgrades in 2021-2022
Growth noted on exterior of tank	n/a	n/a

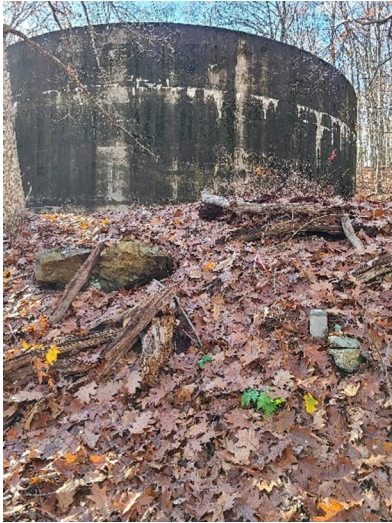
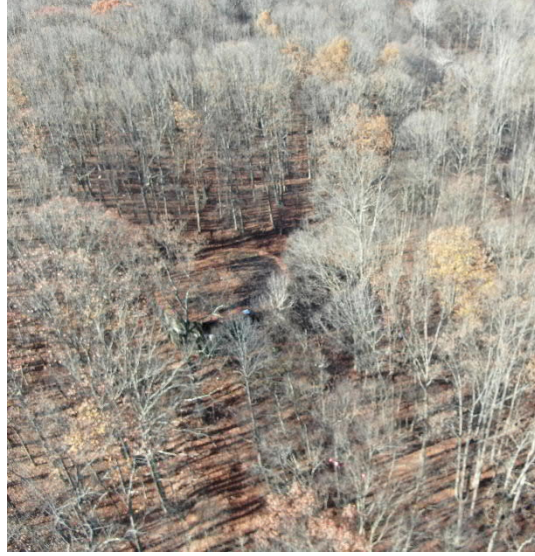
1 MG Tank

The concrete tank sidewalls of the 1.0 MG Tank have shown minor signs of cracking during past site inspections. During the 2022 inspection, the HMUA, Mott MacDonald, and the N.J. Water Association met at the 1.0 MG Tank site. N.J. Water Association used a drone to view the site from above. The drone footage shows the visibility of the existing tank and the proposed tank from nearby properties. Due to the height of the trees compared to the tank height and the distance from nearby properties, the tank is not suspected to be visible from nearby properties. The existing 1.0 MG Tank will be demolished and replaced with a new 1.0 MG tank as a part of Contract 52W.

1.0 MG Water Storage Tank		
2022 Findings by Mott MacDonald	Ongoing Issues / Items to be Addressed	Items addressed / Completed Upgrades in 2021-2022
Based on drone footage taken during the 2022 inspection, the new tank is not suspected to be visible by nearby homes	A project is currently underway to design a new 1 MG water storage tank and demolish existing tank. Permitting and planning Board approval from the Township of Independence is underway.	Access road maintenance

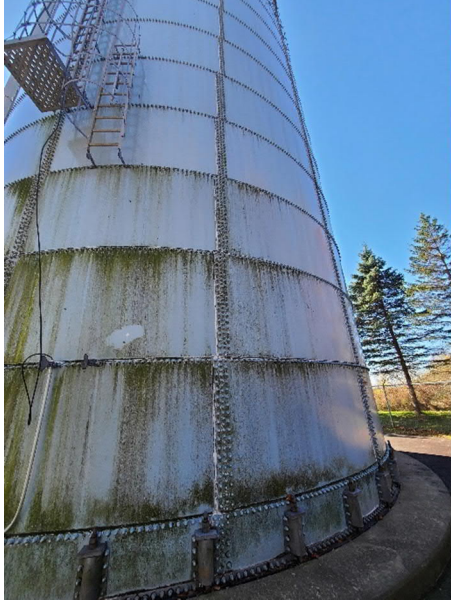
The Mount Olive Township Water Storage Tank is a bolted, fused glass coated steel type construction. During the spring of 2021, the Mount Olive Storage Tank was inspected via a robot. The robot entered the tank from the top hatch and video inspected the interior of the tank. The tank interior appeared to be in excellent condition, no repairs were needed. Some minor growth near the tank base was noted.

Mount Olive Storage Tank Exterior Growth

Mount Olive Twp. Water Storage Tank		
2022 Findings by Mott MacDonald	Ongoing Issues / Items to be Addressed	Items addressed / Completed Upgrades in 2021-2022
Growth near base of tank	n/a	n/a

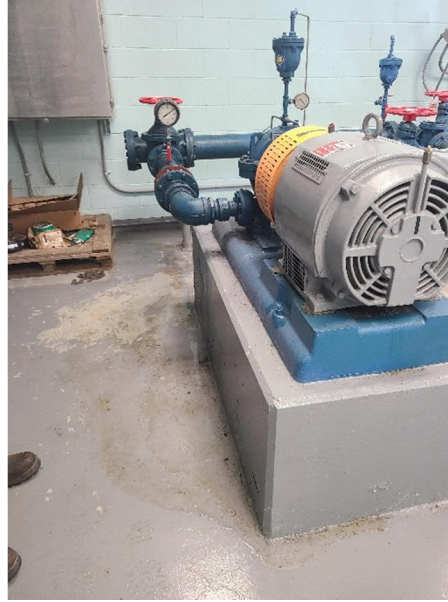
Following previous 2016 repairs to the altitude valve at the Booster Station, HMUA replaced the valve in 2021. Both booster station pumps have been retrofitted with stainless steel impellers following an investigation by Mott MacDonald which found that dezincification of the original Silicon Bronze impellers had occurred. In addition, HMUA has upsized 2" discharge piping to 4" on the pumps. One pump motor was repaired and the other was replaced with a new motor, as it likely was damaged by the leak noted in 2020. During 2021, it was noted that the Well No. 2 antenna was relocated to this location. During the 2022 inspection, as noted in previous reports, growth was observed on the Booster Station roof and the floor coating has failed. Some ongoing leakage at Pump No. 1 was noted as typical.

Mount Olive Booster Station Pumps

Mount Olive Twp. Booster Station		
2022 Findings by Mott MacDonald	Ongoing Issues / Items to be Addressed	Items addressed / Completed Upgrades in 2021-2022
Water leakage at pump was noted	Significant growth on roof was noted. Floor coating has failed Wall coating impacted by previous piping leak.	Spare pump has been ordered

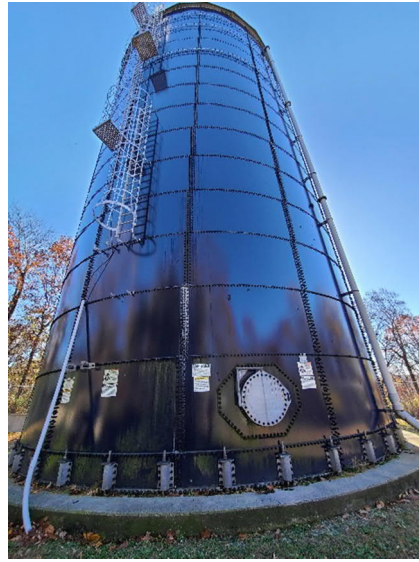
During the November 2022 inspection, the tank appeared to be operating in satisfactory condition. Following the 2021 repairs to the tank, one homeowner had reported pressure issues when HMUA was operating off the temporary tanker truck. HMUA is investigating this concern.

Independence Water Storage Tank		
2022 Findings by Mott MacDonald	Ongoing Issues / Items to be Addressed	Items addressed / Completed Upgrades in 2021-2022
Tank is in satisfactory condition	One homeowner is having issues with low water pressure. HMUA is investigating this.	n/a

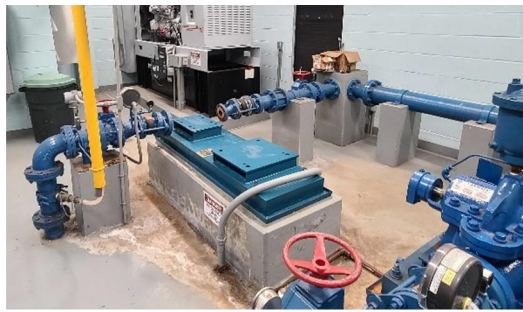
Independence Booster Station – Pump #2

During the November 2022 inspection, it was noted that the Pump #2 and motor remain out for repair, awaiting parts. The altitude valve will be replaced. Altitude valve flanges appear to be buried in concrete. These flanges will be uncovered, shifted, and centered. A spare motor has been ordered.

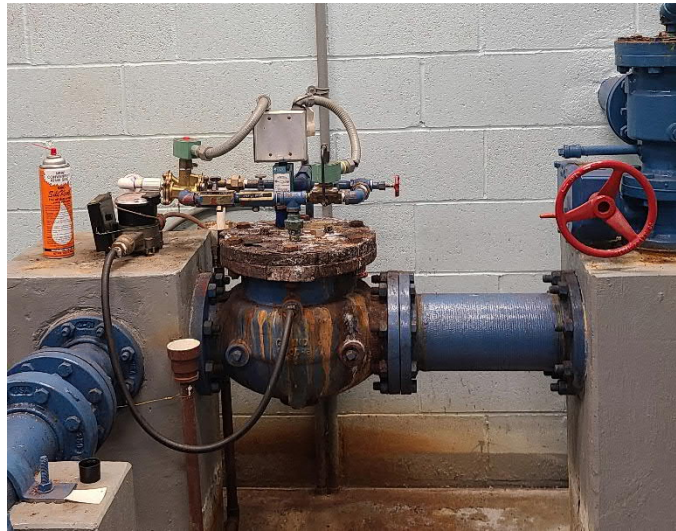
Independence Booster Station – Altitude Valve

Independence Water Booster Station		
2022 Findings by Mott MacDonald	Ongoing Issues / Items to be Addressed	Items addressed / Completed Upgrades in 2021-2022
Altitude valve is noted to be replaced.	Pump #2 and motor are with Longo for repairs	Spare motor has been ordered

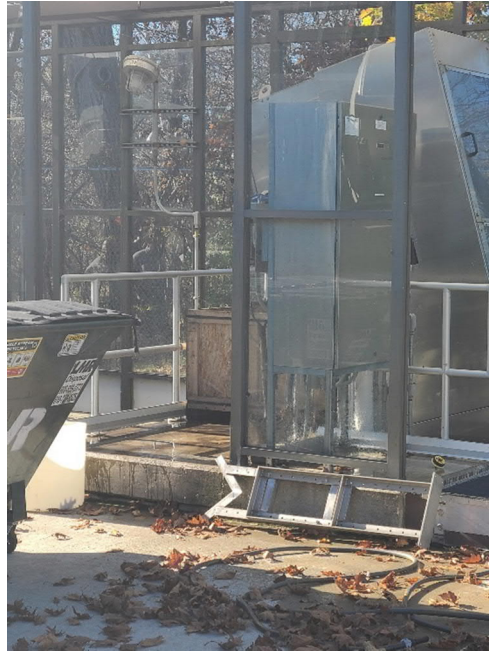
Bar Screen

Inlet Facilities and Raw Sewage Pumping		
2022 Findings by Mott MacDonald	Ongoing Issues / Items to be Addressed	Items addressed / Completed Upgrades in 2021-2022
Diversion box is cleaned approximately every 6-months.	Compactor gearbox replacement.	n/a

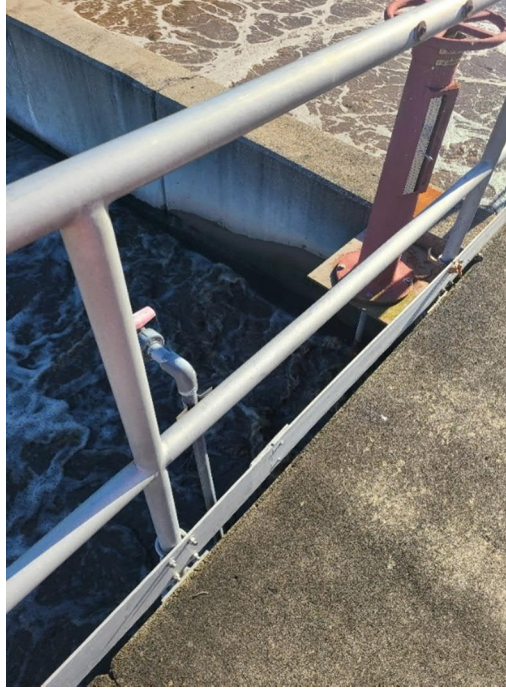
In 2017, Mott MacDonald carried out an evaluation of options for diffuser replacement as the existing swing-arm mechanisms were no longer manufactured, and other diffuser designs offer higher efficiency. HMUA completed Contract 48S which included diffuser and mixer replacement in July 2019. During the October 2020 inspection, large darker bubbles were noted in the Nitrification Tank, the bubbles appear to start midway through the tanks. HMUA monitored this throughout 2021 and determined it didn't impact their system and wasn't a concern. In October 2021, it was noted that a leak has been detected at the bleed-off connection point to the new diffusers in one tank. During the November 2022 inspection, the leak in the aerator was still present in the anoxic tank. In order to resolve this, the entire tank will need to be drained.

Nitrification Tanks – Leak at diffuser bleed-off

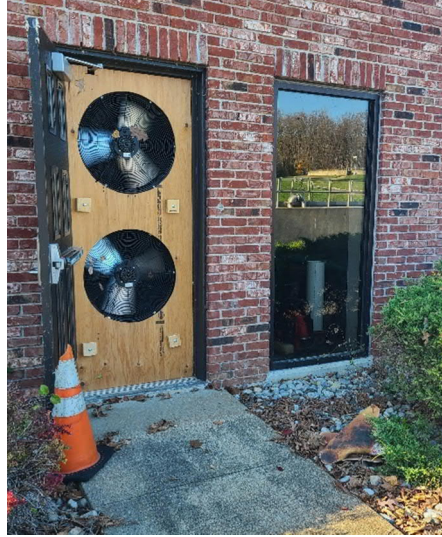
Blower Room – Positive Pressure System

The HMUA aerated both of the Nitrification Tanks with a single 125 hp constant speed blower for many years. The 1991 plant upgrade and expansion provided four (4) constant speed centrifugal blowers with 125 hp motors. As recommended by the Energy Audit prepared by CDM, the HMUA completed Contract No. 39S to replace two (2) of the four (4) existing 125 hp constant speed centrifugal blowers with more efficient variable speed turbo blowers and to reduce the air flow capacity of the blowers based on the actual plant operating conditions. Two (2) new 75 hp turbo blowers with VFDs and controls were installed and have been operational since early 2012. A single turbo blower typically meets plant air demands for both Nitrification Tanks. The installation of the new turbo blowers has resulted in energy costs savings to the HMUA. In 2015, a VFD issue with one of the blowers was reported. Though repairs occurred in 2016, VFD issues persisted and a constant speed blower had been in operation. In 2017, HMUA worked with Neuros to analyze the blower issues. Air sampling suggested that H₂S from thickening operations was resulting in corrosion of the electronic components. Replacement of one VFD (with enhanced coatings) and the PLC was completed in 2017. A second replacement VFD was also installed. HMUA improved the seal on the door leading to the blower room, maintained louvers in the open position and tested a new filter style as part of addressing the corrosion issue. With the diffuser replacement under Contract 48S, the turbo blowers have been operating at reduced speeds while meeting the plant air demands. In 2020 the Master Control Panel PLC was replaced, the programming was updated, and replacement PLCs were installed for both blowers. In 2021, the communication cable from Blower 4 to Master Blower Control Panel had issues, the issue has been resolved with the use of an external cable. During the 2022 inspection, it was noted that a positive pressure system was being utilized for the blower room. Air corrosivity is being monitored via coupons installed outside the Blower Room.

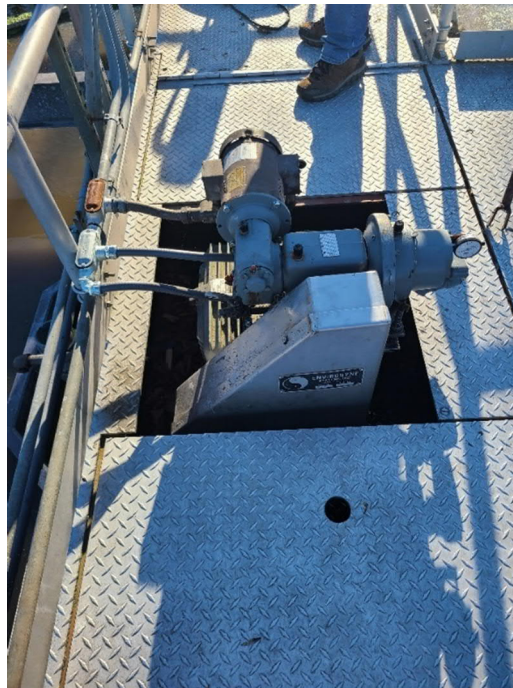
During the November 2022 inspection, HMUA noted a new WinSmith was installed in the Final Clarifier No. 1.

Final Clarifier No. 1 – New WinSmith

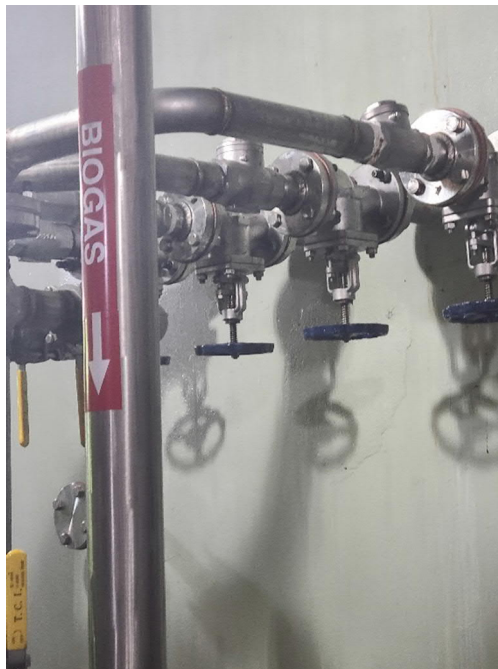
Replaced Check Valves

In 2022, two check valves on the sludge lines were replaced by HMUA and two check valves were cleaned for proper operation.

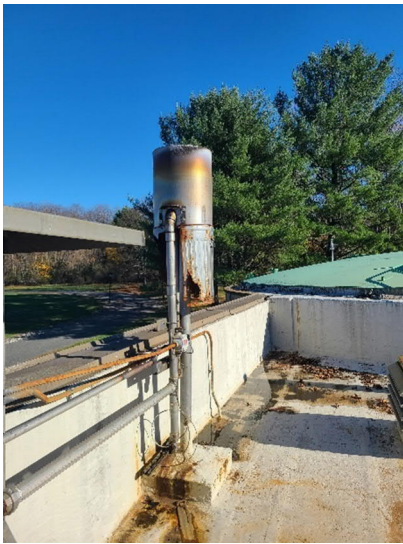
Flare on roof of Digester Building

During the November 2022 inspection, the flare on the roof of the digester building was inspected. The flare was working and some of the piping to the flare was rusted. Water ponding on the roof was observed. The HMUA is reviewing options for the use of natural gas for the flare in the future.

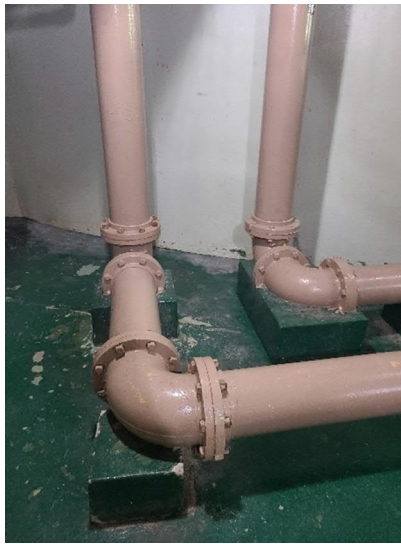
Digested Sludge Piping

HMUA staff had previously noted clarifier issues when the supernatant is recycled, so the flow had been directed to the pre-thickened sludge wet well. During the November 2022 inspection, it was noted supernatant is now being returned to the head of the plant. In 2021 the HMUA redid the exterior coating on the supernatant piping. A struvite build-up has been identified in the digested sludge line – the pipe clogs over the course of a three-year period. HMUA staff cleaned sections of digester overflow piping in September 2019 and again in 2021. In 2021 the HMUA staff took apart the fittings twice throughout the year to clean portions of the digested sludge piping that was clogging. The HMUA is considering replacing the pipes with PVC.
