2023 Annual Facilities Inspection Report

Hackettstown Municipal Utilities Authority

January 2024

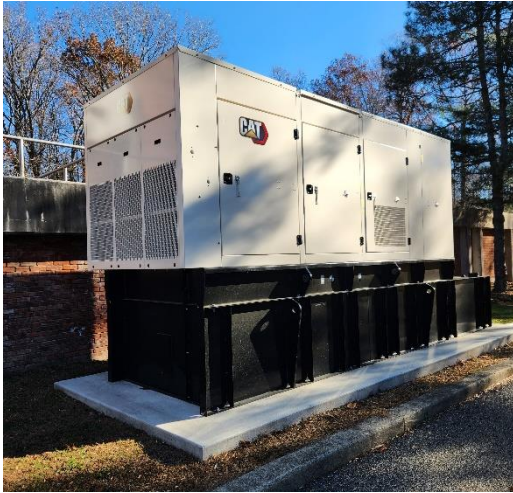
In October 2021, it was noted the site generator would be replaced, as the current generator was beyond repair. In November 2022, an external temporary generator had been installed at the site outside of the building. A new outdoor pad and conduits to the automatic transfer

switch in the Generator room were installed. The new generator arrived on 11/28/2022 and was fully installed on site. During the November 2023 inspection, it was noted the HMUA is waiting on SCADA connection to the generator.

New Generator

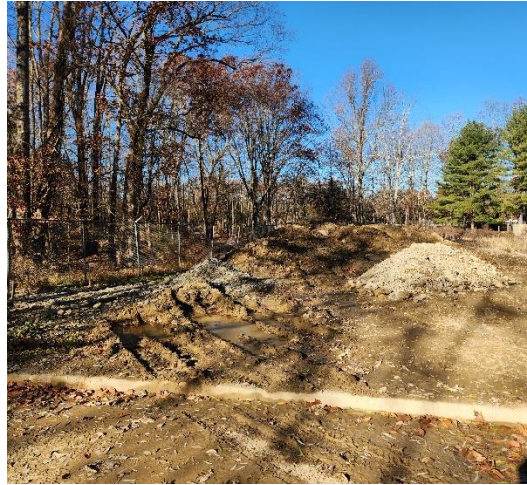
In 2020, the HMUA completed a spoil disposal project under Contract 49W. HMUA has put some temporary spoils at the site from various water main break repairs throughout the past years. During November 2022, temporary spoils and stockpiles were all removed from the site. During November 2023 inspection, the site was being used by the HMUA to stockpile.

In 2021, the northeast fence behind the site was temporarily repaired, and damage was noted on the fence in the southwest portion of the site was damaged. Both remain to be addressed.

Stockpile and Damaged Fence

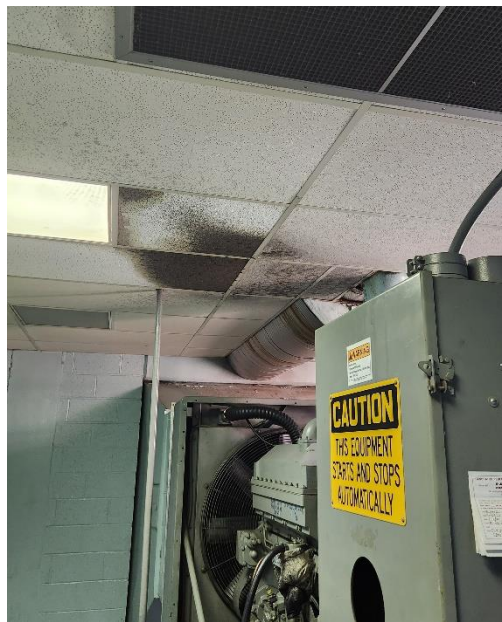
In November 2022, a leak was found near a window inside the site, it was noted to be an ongoing leak for approximately 6 months. During the November 2023 inspection, water damage to some ceiling panels was noted at the water filtration plant building. The external contact tanks on site were reported as being drained monthly.

Damaged Ceiling Panels - Old Generator Room

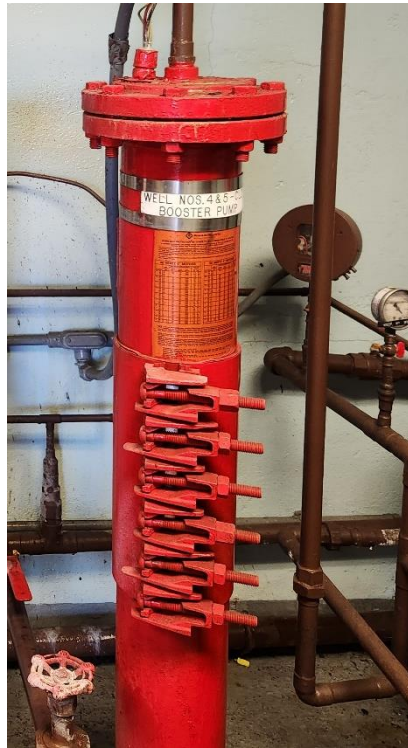
Well No. 4 – Booster Pump

Well No. 4 – Seber		
2023 Findings by Mott MacDonald	Ongoing Issues / Items to be Addressed	Items addressed / Completed Upgrades in 2022-2023
Well No. 4 is running around 8 hours a day while Well No. 8 is out of service	Water mark on ceiling tile is being monitored, there is a hatch on the roof above the water mark	n/a

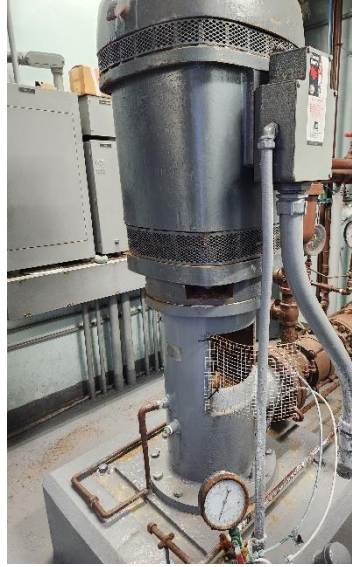
Concrete damage has been noted on the walls during recent inspections, though it appears to be mostly a cosmetic issue.

Well No. 6 - Heath		
2023 Findings by Mott MacDonald	Ongoing Issues / Items to be Addressed	Items addressed / Completed Upgrades in 2022-2023
<p>Cosmetic concrete damage is still present on walls</p> <p>Constant ChlorPlus equipment has been moved to the Chlorine Room.</p>	<p>The HMUA is planning to install the chlorine tab equipment in a more permanent manner.</p>	<p>n/a</p>

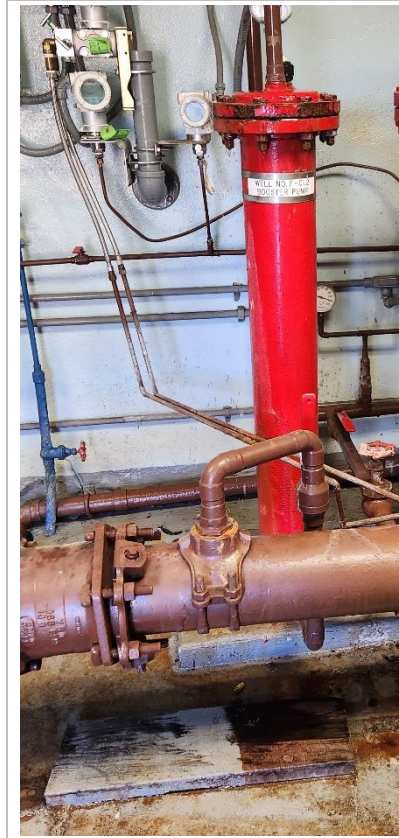
The detention main butterfly valve for Well No. 7 remains out of service (in the open position). Controls for Well No. 7 are housed in the Well No. 4 building. The pressure relief valve was replaced during 2021. During the November 2023 inspection, it was noted that the Well No. 7 Booster Pump was leaking; however, this is typical for this well.

Well No. 7 - Leaking

Well No. 7 – Seber		
2023 Findings by Mott MacDonald	Ongoing Issues / Items to be Addressed	Items addressed / Completed Upgrades in 2022-2023
Well No. 7 is leaky, however HMUA noted this is typical for when this well is running.	n/a	n/a

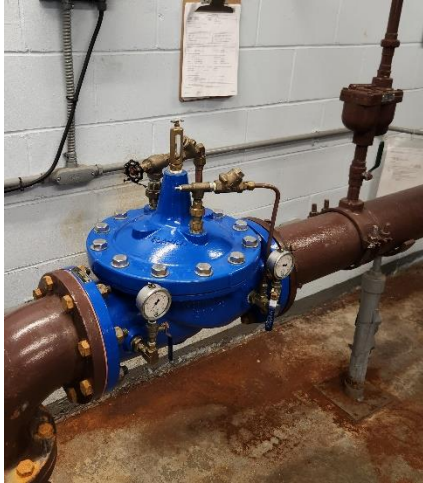
New Check Valve

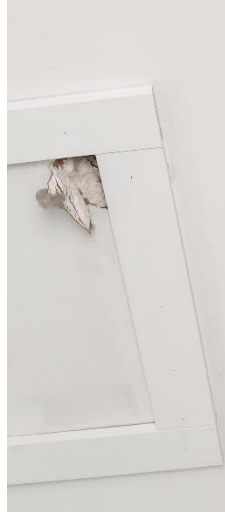
Damaged Hatch

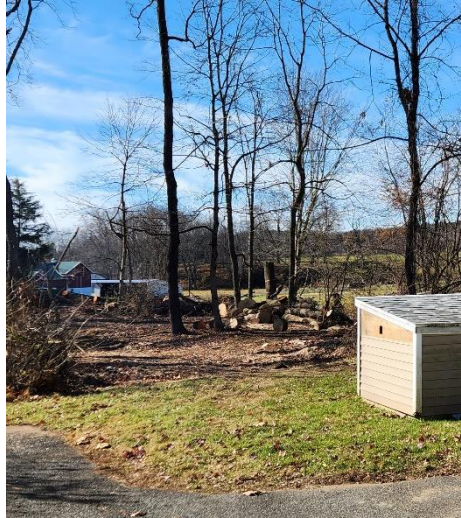
During the November 2023 inspection, Well No. 8 was noted to have failed in mid-October 2023. The Well is not functioning as the pump and motor have failed and will be replaced. The well's piping is currently on the grass behind the Well No. 8 building while the pump and motor for the well are being replaced. The check valve was replaced in September 2023. The hatch in the ceiling of the building was noted to have minor damage during November 2023 and should be monitored. One of the trees in the back of the property one fell on a neighbor's garage. The HMUA has since cut down trees on the property.

Tree removal at Site

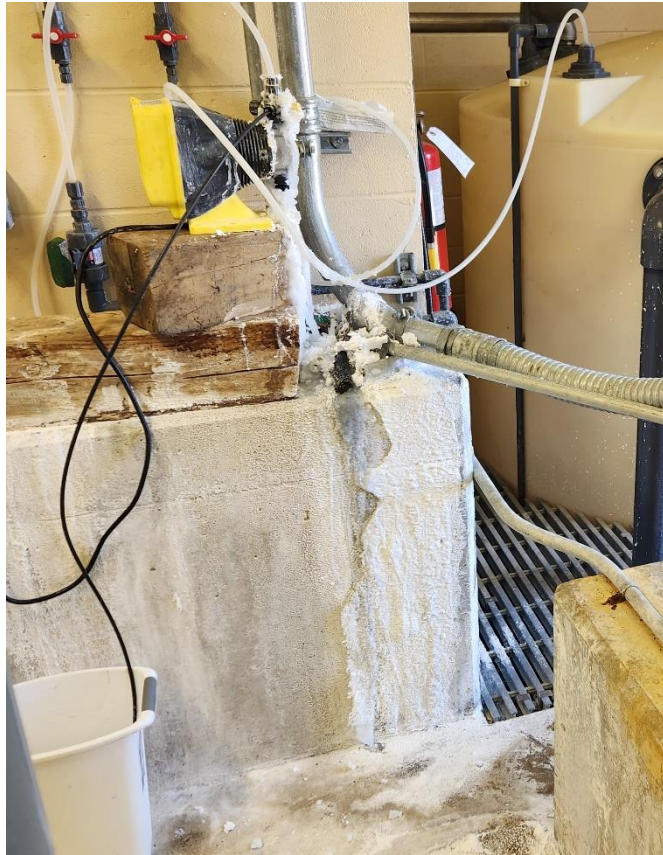
Well No. 9 became operational in 2015 and has been in continuous use since that time. Since being placed into service, HMUA added a radar sensor for monitoring the chemical tank level at Well No. 9 and installed a gate as required by Washington Township. During 2021 and 2022, the HMUA noted that water on the floor of the well house is a common occurrence due to condensation and the lack of a floor drain, the HMUA noted the quantity of water is greater than normal when a sample is taken. During the November 2023 inspection, the floor of the building was dry. Currently Well No. 9 is the only well adding ortho-phosphate to the system. During the November 2023 inspection, there was a buildup of chemicals near the pump. This is due to a leaky dosing pump which the HMUA has plans to replace.

Well No. 9 – Leaky Dosing Pump

Well No. 9 - Heath		
2023 Findings by Mott MacDonald	Ongoing Issues / Items to be Addressed	Items addressed / Completed Upgrades in 2022-2023
Floor of the Well House was dry. Currently Well No. 9 is the only well adding ortho-phosphate to the system.	Chemical Dosing Pump is leaky and HMUA plans to replace.	n/a

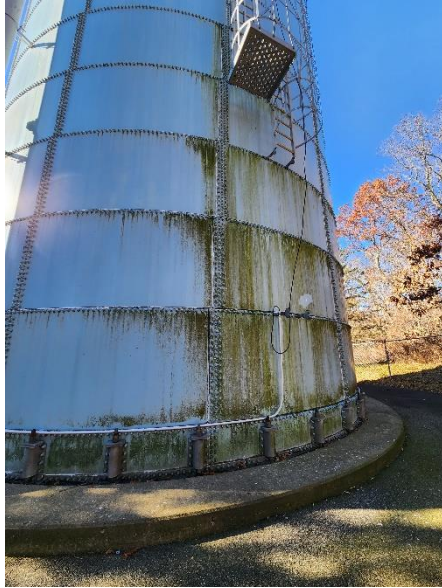
The Mount Olive Township Water Storage Tank is a bolted, fused glass coated steel type construction. During the spring of 2021, the Mount Olive Storage Tank was inspected via a robot. The robot entered the tank from the top hatch and video inspected the interior of the tank. The tank interior appeared to be in excellent condition, no repairs were needed. Some minor growth near the tank base was noted.

Mount Olive Storage Tank Exterior Growth

Mount Olive Twp. Water Storage Tank		
2023 Findings by Mott MacDonald	Ongoing Issues / Items to be Addressed	Items addressed / Completed Upgrades in 2022-2023
Growth near base of tank	n/a	n/a

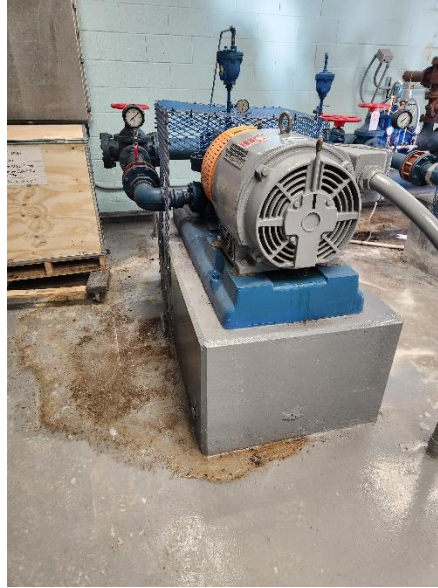
Following previous 2016 repairs to the altitude valve at the Booster Station, HMUA replaced the valve in 2021. Both booster station pumps have been retrofitted with stainless steel impellers following an investigation by Mott MacDonald which found that dezincification of the original Silicon Bronze impellers had occurred. In addition, HMUA has upsized 2” discharge piping to 4” on the pumps. One pump motor was repaired and the other was replaced with a new motor, as it likely was damaged by the leak noted in 2020. During 2021, it was noted that the Well No. 2 antenna was relocated to this location. During the 2023 inspection, as noted in previous reports, growth was observed on the Booster Station roof, roots are growing over the edges of the roof, and the floor coating has failed. Some ongoing leakage at Pump No. 1 was noted as typical. The HMUA plans to replace Pump No. 1 with a spare pump over the winter and send Pump No. 1 out for repair. Pump No. 1 will become the spare pump once it has been rebuilt. Some trees on the site have been trimmed and cut.

Mount Olive Booster Station Pump and Spare

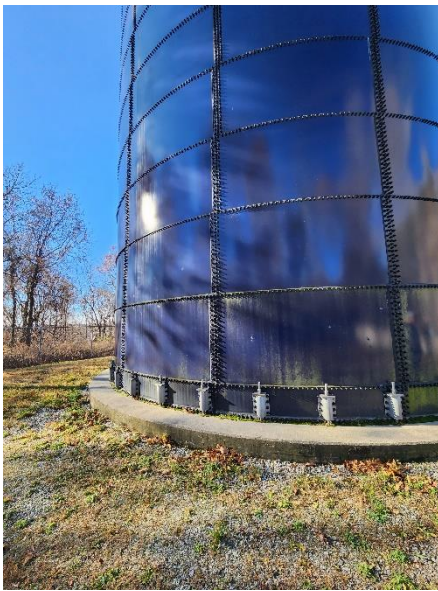
During the November 2023 inspection, the tank appeared to be operating in satisfactory condition and the fence behind the tank was slightly damaged.

Independence Water Storage Tank

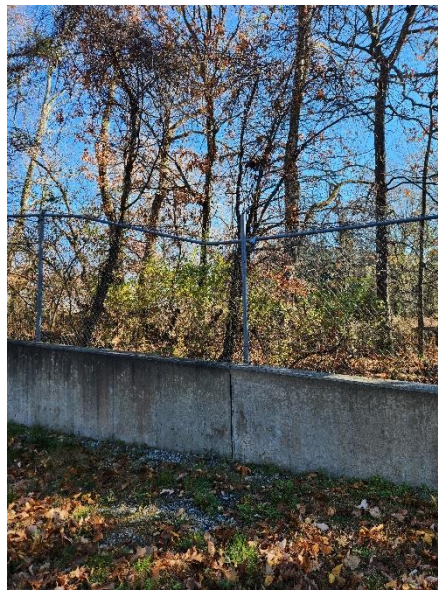
Damaged Fence

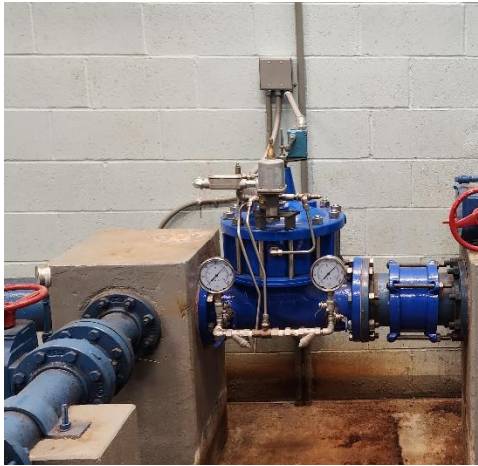
During the November 2023 inspection, it was noted that the Pump #2 and motor have been repaired. The altitude valve was replaced. A spare motor was ordered during 2022. A spare pump has been received but has not been installed. Pump No. 2 has a slight leak at the flexible coupling.

Independence Booster Station – Altitude Valve

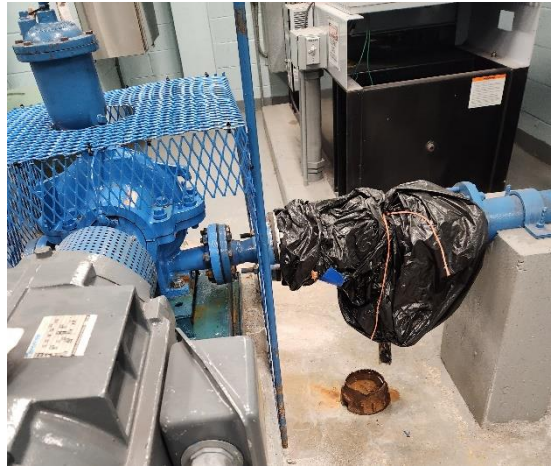
Independence Booster Station – Pump #2 Flexible Coupling

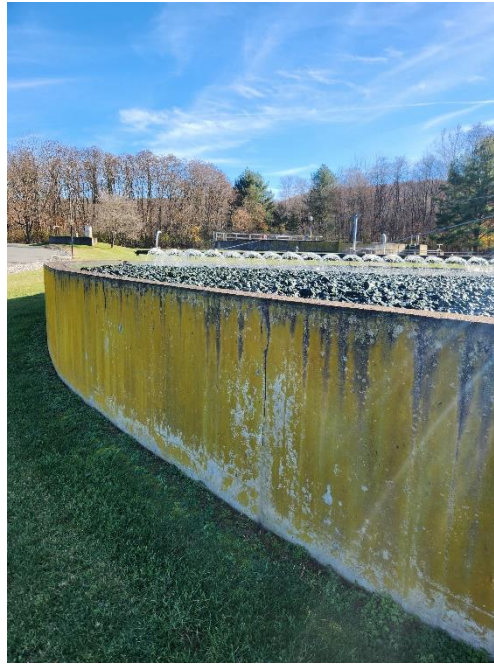
Primary & Secondary Treatment		
2023 Findings by Mott MacDonald	Ongoing Issues / Items to be Addressed	Items addressed / Completed Upgrades in 2022-2023
Minor Spalling near center column in Intermediate Clarifier No. 2 have been noted previously.	Several items at Intermediate Pump Station – Floor, Roof and Pump Controls. HMUA received prices for some of these repairs. HMUA is obtaining a quote to re-coat Intermediate Clarifier No. 2 HMUA is obtaining a quote for concrete repairs at Trickling Filter No. 1	n/a

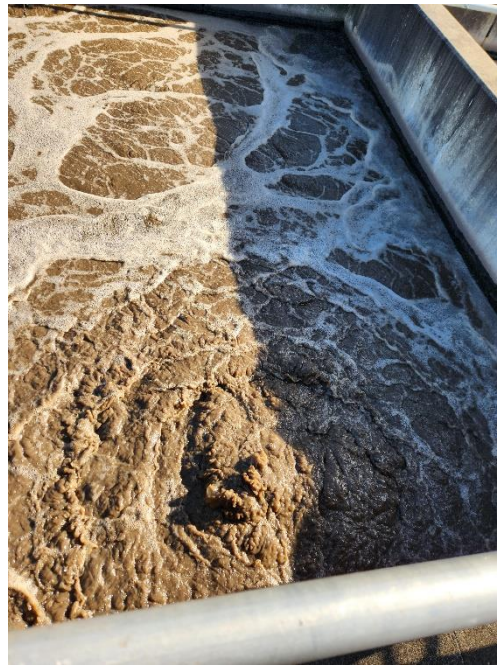
In 2017, Mott MacDonald carried out an evaluation of options for diffuser replacement as the existing swing-arm mechanisms were no longer manufactured, and other diffuser designs offer higher efficiency. HMUA completed Contract 48S which included diffuser and mixer replacement in July 2019. During the October 2020 inspection, large darker bubbles were noted in the Nitrification Tank, the bubbles appear to start midway through the tanks. HMUA monitored this throughout 2021 and determined it didn't impact their system and wasn't a concern. In October 2021, it was noted that a leak has been detected at the bleed-off connection point to the new diffusers in one tank. During the November 2023 inspection, the leak in the aerator was still present in the anoxic tank. To resolve this, the entire tank will need to be drained.

Nitrification Tanks – Leak at diffuser bleed-off

Advanced Treatment		
2023 Findings by Mott MacDonald	Ongoing Issues / Items to be Addressed	Items addressed / Completed Upgrades in 2022-2023
n/a	Address diffuser blow-off leak. Blowers No. 2 and No. 4 are down and being repaired. Floc motor and speed controller at final clarifiers are being repaired.	Non-Potable Tank was replaced. Shut off Valve on Final Clarifier No. 1 was replaced.

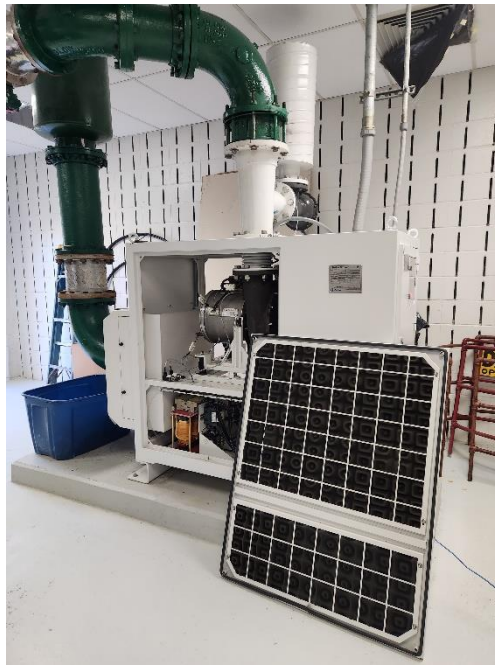
The HMUA aerated both of the Nitrification Tanks with a single 125 hp constant speed blower for many years. The 1991 plant upgrade and expansion provided four (4) constant speed centrifugal blowers with 125 hp motors. As recommended by the Energy Audit prepared by CDM, the HMUA completed Contract No. 39S to replace two (2) of the four (4) existing 125 hp constant speed centrifugal blowers with more efficient variable speed turbo blowers and to reduce the air flow capacity of the blowers based on the actual plant operating conditions. Two (2) new 75 hp turbo blowers with VFDs and controls were installed and have been operational since early 2012. A single turbo blower typically meets plant air demands for both Nitrification Tanks. The installation of the new turbo blowers has resulted in energy costs savings to the HMUA. In 2015, a VFD issue with one of the blowers was reported. Though repairs occurred in 2016, VFD issues persisted and a constant speed blower had been in operation. In 2017, HMUA worked with Neuros to analyze the blower issues. Air sampling suggested that H₂S from

thickening operations was resulting in corrosion of the electronic components. Replacement of one VFD (with enhanced coatings) and the PLC was completed in 2017. A second replacement VFD was also installed. HMUA improved the seal on the door leading to the blower room, maintained louvers in the open position and tested a new filter style as part of addressing the corrosion issue. With the diffuser replacement under Contract 48S, the turbo blowers have been operating at reduced speeds while meeting the plant air demands. In 2020 the Master Control Panel PLC was replaced, the programming was updated, and replacement PLCs were installed for both blowers. In 2021, the communication cable from Blower 4 to Master Blower Control Panel had issues, the issue has been resolved with the use of an external cable. During 2022, it was noted that a positive pressure system was being utilized for the blower room. Air corrosivity is being monitored via coupons installed outside the Blower Room. During the November 2023 inspection, it was noted that the two newer blowers aren't working, and the old blowers are back in use. Blower No. 2 requires PLC updates and may require replacements. Blower No. 4 has had work done; the core was replaced under previous warranty. The HMUA is looking into an odor logger that can measure in parts per billion. The HMUA is considering fully sealing the door that leads to the belt thickeners to help with the corrosion issues.

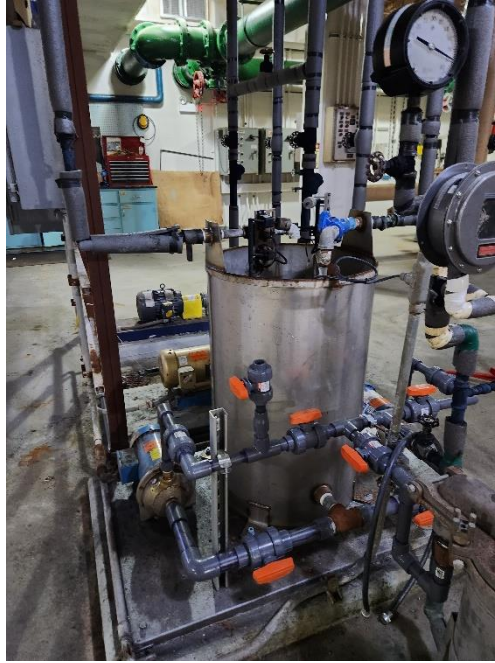
During the November 2023 inspection, it was reported that the Non-Potable Tank was replaced.

Non-Potable Tank

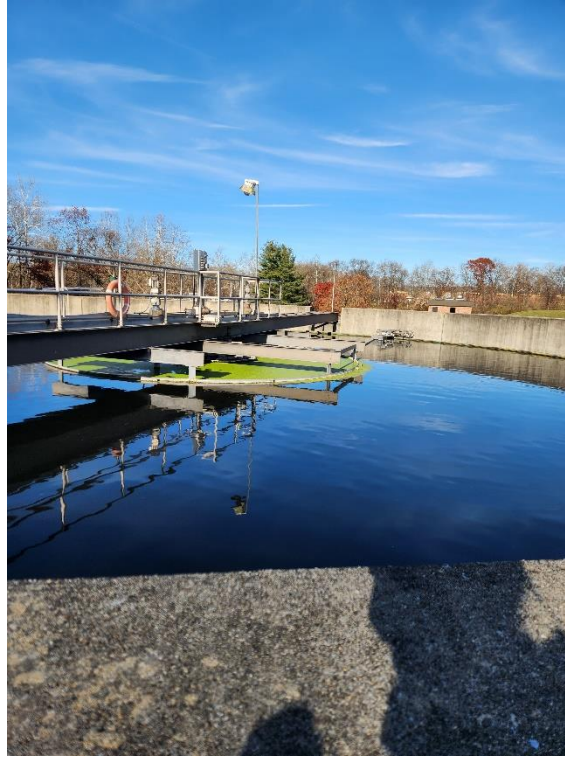
During the November 2023 inspection, the HMUA reported that the floc was down in both Final Clarifiers. Final Clarifier No. 1 is having the floc motor and speed controller rebuilt. This will be tested in Final Clarifier No. 1 before the Final Clarifier No. 2 floc motor and speed controller is rebuilt.

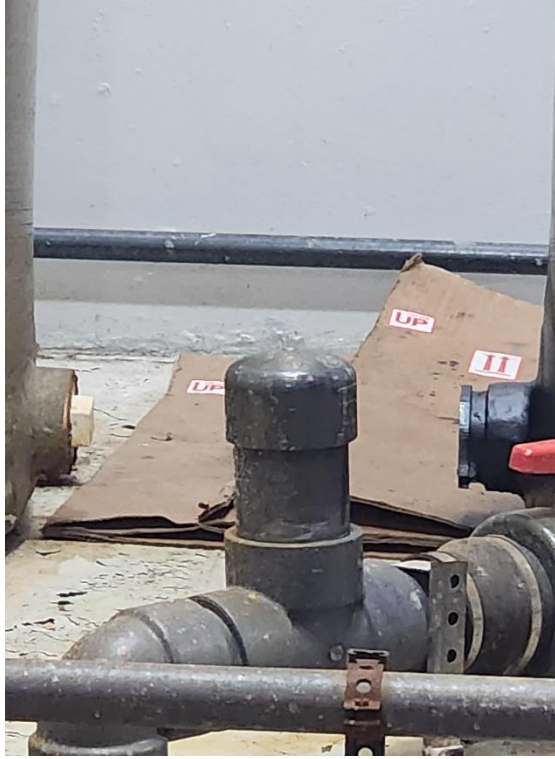
Fixed Alum Tank Leak

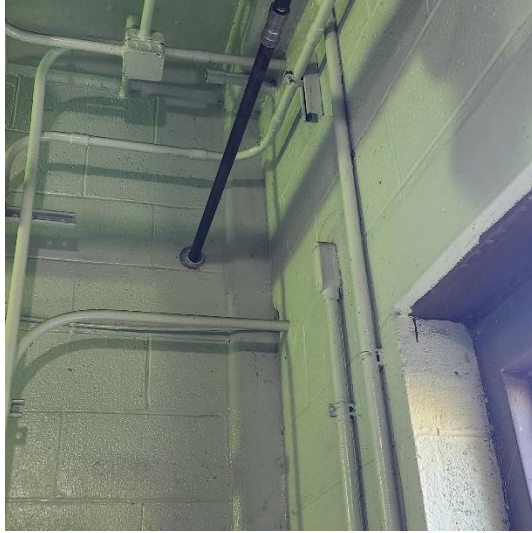
During November 2022, the flare on the roof of the digester building was working and some of the piping to the flare was rusted. Water ponding on the roof was observed.

Piping for Flare

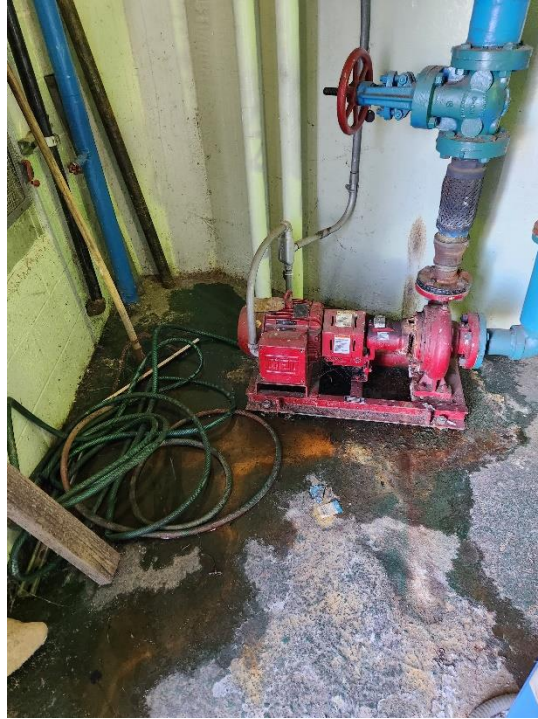
Leaking Hot Water Heater

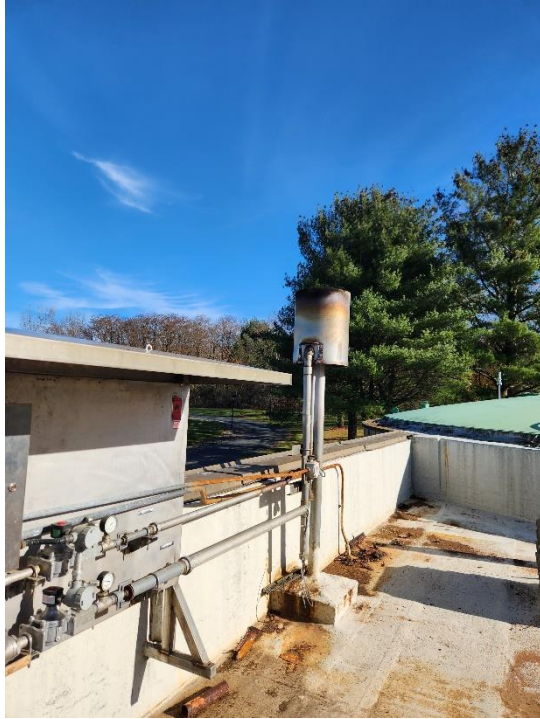
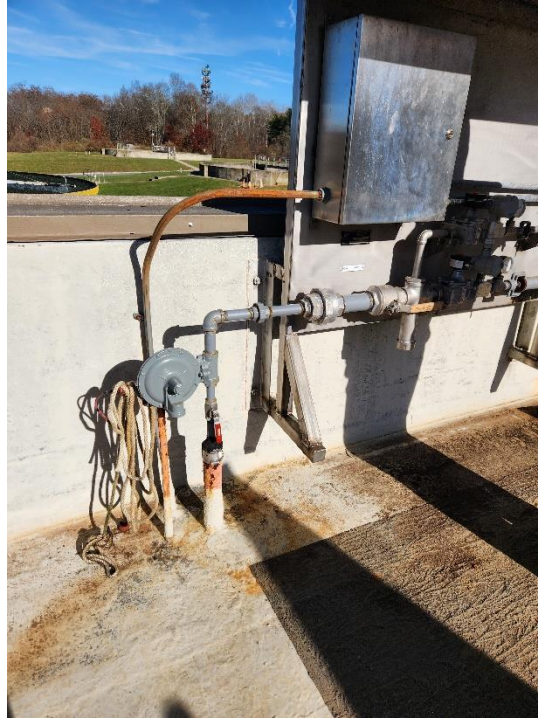
During the November 2023 inspection, the flare now is connected to natural gas and has a natural gas pilot. An old pipe opening was utilized and the natural gas piping goes through the wall for the flare. The water heater is leaking in the room with the generator; by the end of this year the HMUA will replace the heater and send the leaking one out for repair. The insulation on some of the piping for the generator is damaged.

Flare on roof of Digester Building

Flare Piping

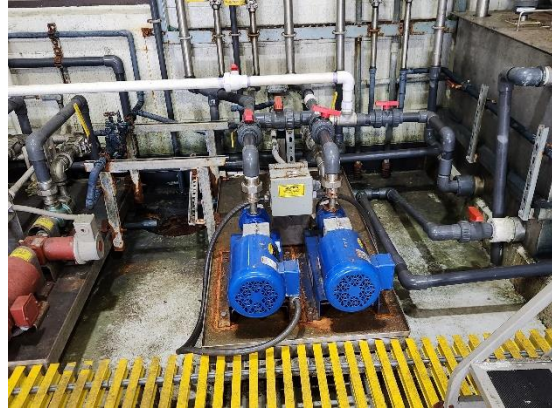
During the November 2023 inspection, it was reported that one polymer pump has been replaced.

Polymer Pump
