**2011 Annual Facilities Inspection Report  
Hackettstown Municipal Utilities Authority**

**December 2011**

**Re: Annual Facilities Inspection 2011**

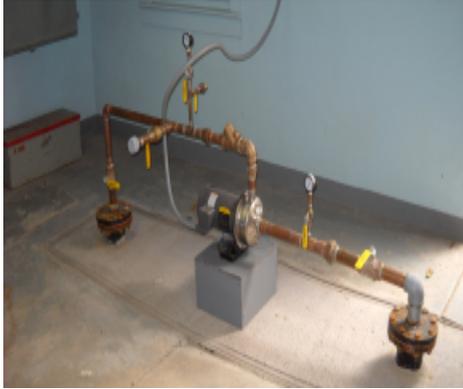
Well No. 2 was taken out of service in early November 2010 due to a failed water quality test (detection of E-Coli). The well remains out of service and the HMUA installed equipment to pump system water up to the IMG Tank.

Well No. 2  
Temporary Pump Arrangement

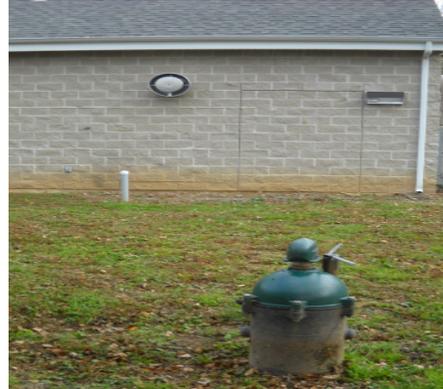
Well No. 8  
New Well Pump

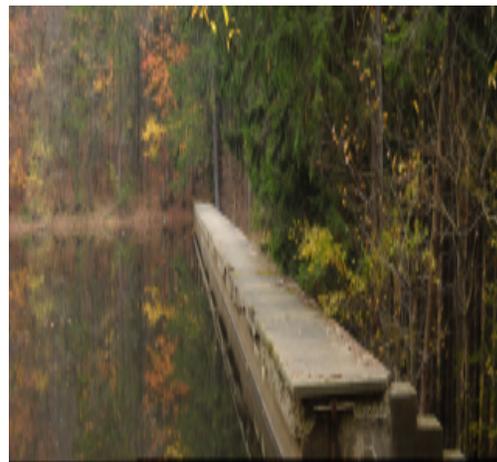
Deterioration of the concrete on the upstream face of the Upper Mine Hill Reservoir Dam has been noted in past facilities inspections as well as the inspection on October 24, 2011. The deterioration is occurring at the top of the dam which is alternately submerged and exposed to the weather during the normal fill and draw of the reservoir. The concrete deterioration appears to be confined to the western half of the upstream dam face. The HMUA has dropped the water level in the Upper Mine Hill Reservoir in the past to allow inspection of the extent of the concrete deterioration and also to prevent the freezing and thawing during the winter months from causing any additional spalling. If the HMUA decides to keep the reservoirs in service and/or to maintain ownership, it is recommended that the HMUA undertake a concrete repair project for the above section of the Upper Mine Hill Reservoir Dam while the extent of the required repairs is limited.

Upper Mine Hill Reservoir Dam -  
Concrete Deterioration on the Upper  
Portion of Upstream Face of Dam

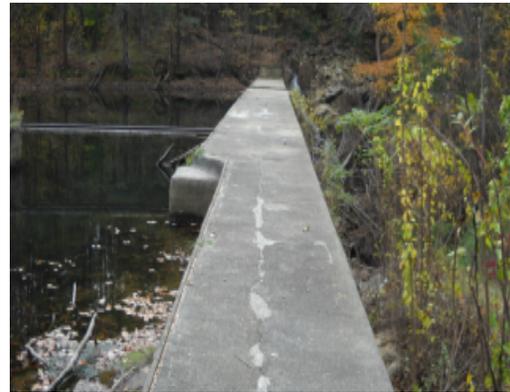
During 2011, the HMUA removed trees from embankment adjacent to dam and also removed trees, branches and brush along toe of dam to facilitate observation of toe. It should be noted that the HMUA made concrete repairs to the crest of the Lower Mine Hill Dam in April 2008 and these repairs appear to be in satisfactory condition.

Lower Mine Hill Reservoir Dam -  
Concrete Repairs to Top of Dam

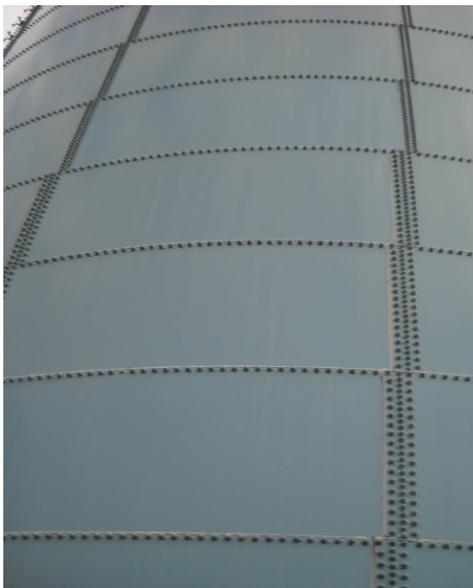
The Mount Olive Township Water Storage Tank appeared to be in excellent physical condition during our October 2011 site inspection. One of pump motors at the Mount Olive Water Booster Pump Station was undergoing repairs at the time of the inspection and a spare motor was in use.

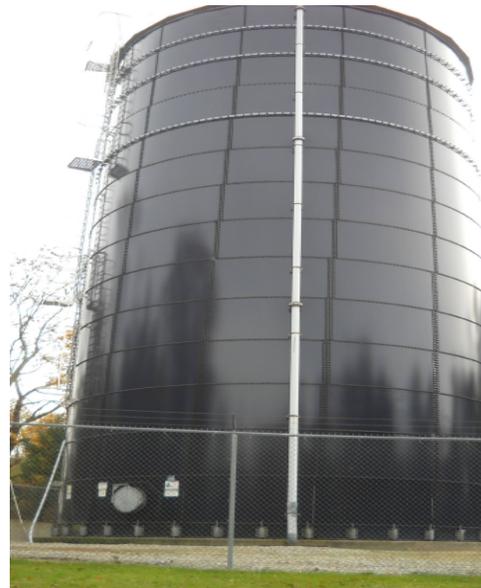
It was reported by the HMUA that there was some areas of weepage at the Independence Township Water Storage Tank during 2008. These areas of weepage on the tank were repaired by an outside contractor during the fall of 2008 and these repairs appear to be holding up well. No weepage was observed during our October 2011 field inspection and the exterior of the tank appeared to be in satisfactory condition.

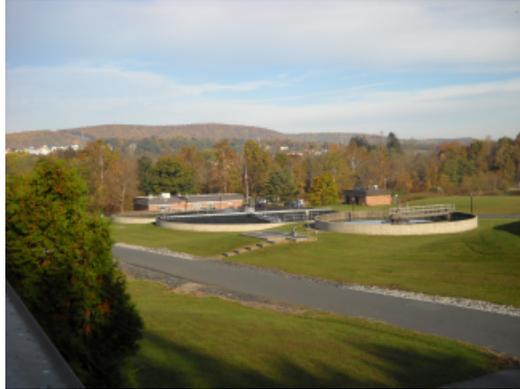
Water Pollution Control Plant Site

Under a Power Purchase Agreement, the HMUA has installed a 31.7 kW solar array at the WPCP Site. The installation was completed in September 2011, with an official ribbon-cutting ceremony on October 6, 2011.

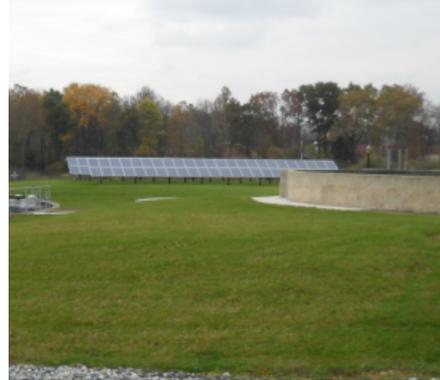
Solar Panels at WPCP Site

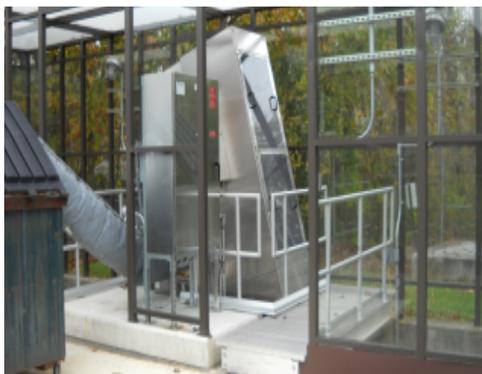
Raw Sewage Screen

As mentioned in the 2008 Annual Inspection Report and as recommended in the Feasibility Report prepared by CH2M Hill, the HMUA has undertaken a project for the construction of screening and washing facilities for the removal of screenings at the head of the plant. The new Screening, Washing and Compacting Equipment were installed in November 2010. The HMUA reported that equipment is working well and they have been making adjustments to improve efficiency of the Washing

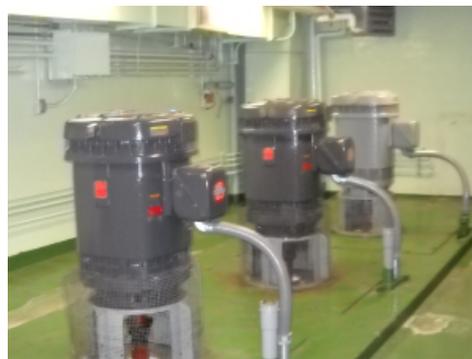
New motors and VFDs for Raw Sewage Pumps No. 1 and No. 2 have been installed under Contract No. 37S. The HMUA is planning to replace the existing Raw Sewage Pump Control Panel in the near future.

Raw Sewage Pump Motors

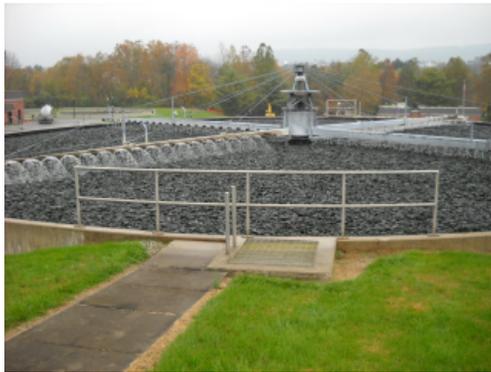
Both trickling filters were in operation during our site inspection and reported and appeared to be in satisfactory condition. All three (3) of the trickling filter recirculation pumps were reported to be operating properly. Trickling Filter No. 2 had been out of service following the complete of piping modifications, but was returned to operation in advance of Hurricane Irene, and has remained in service.

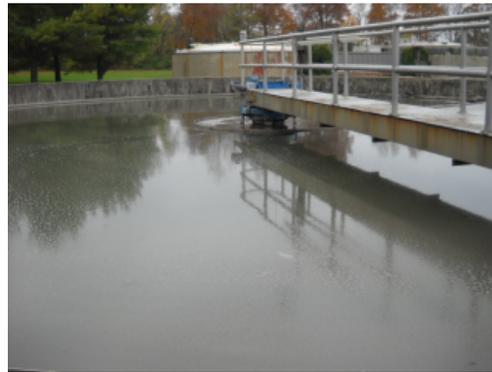
Primary Clarifier

Both primary clarifiers were in operation during our site inspection. The HMUA reported that both primary clarifiers are in satisfactory condition.

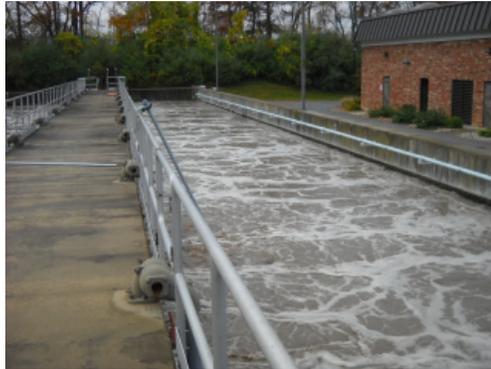
Nitrification Tanks

In 2011, HMUA staff changed out diffusers in one Nitrification Zone. Diffusers were last inspected in 2005 and were found to be in good operating condition. It is recommended that the condition of the remaining diffusers be inspected again in the near future. HMUA noted the plan to inspect and clean the remaining diffusers. The

three (3) Nitrification Tank internal recycle pumps were reported to be in satisfactory operating condition.

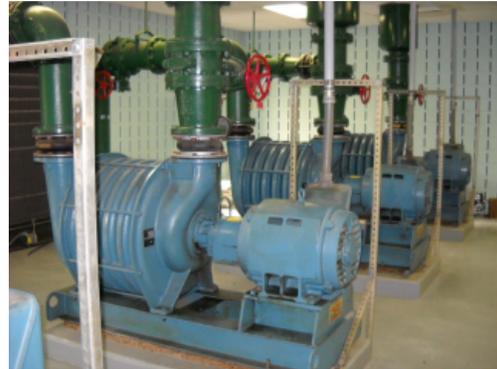
Aeration Blowers

The HMUA has aerated both of the Nitrification Tanks with a single blower for many years. The plant upgrade and expansion provided four blowers. The flows to the plant have not reached design values and sound design practice includes one spare blower. As recommended by the Energy Audit prepared by CDM, the HMUA has a project (Contract No. 39S) underway to replace the existing blowers with more efficient blowers and to reduce the air flow capacity of the blowers based on the actual plant operating conditions. It is anticipated that the new blowers and controls will be operational by the end of 2011.

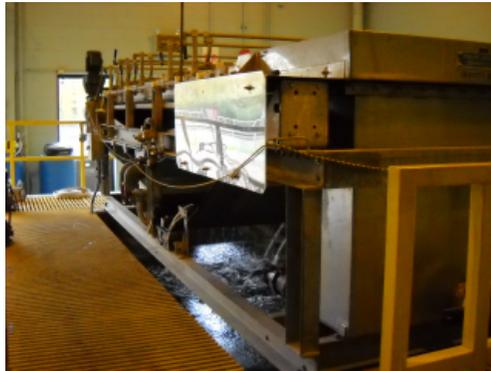
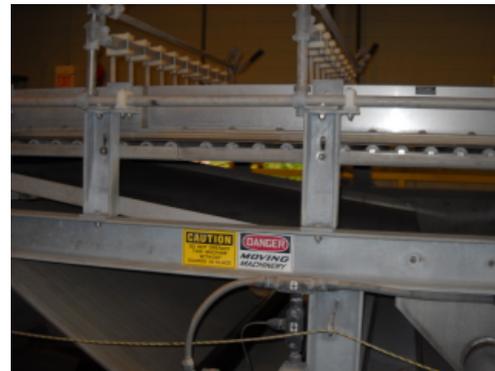
Gravity Belt Thickener

gravity belt thickeners are now eighteen (18) years old, but continue to operate very well, requiring only occasional miscellaneous repairs. A number of the rollers beneath the traveling belts are showing signs of wear and the HMUA has been periodically replacing these rollers as required. The gravity belt thickeners are typically operated three (3) days per week. The positive displacement pumps used in conjunction with the gravity belts are reported to have operated satisfactorily over the past year.
