# 2019 Annual Facilities Inspection Report

Hackettstown Municipal Utilities Authority

December 20, 2019

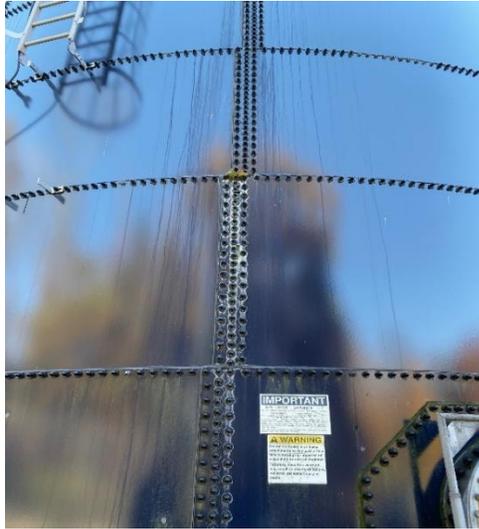
The Independence Township Water Storage Tank has been repaired for leaks in 2008, 2012, 2015, 2016 and again in August 2018. No weepage was observed during our October 2019 field inspection and the exterior of the tank appeared to be in satisfactory condition. At a four way joint connection of the plates, there was a small growth of moss, which should be monitored. No issues were noted at the booster station during the 2019 inspection.

Independence Water Storage Tank  
Growth observed at Joint

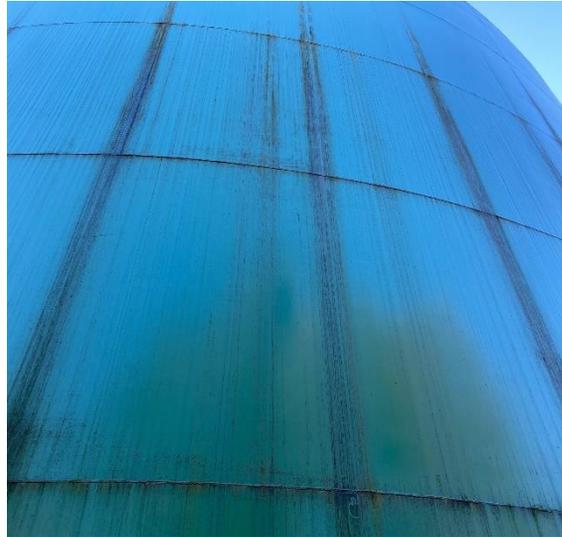
Areas of corrosion were noted on the tank exterior during the November 2014 inspection as well as during the 2012 and 2013 facilities inspections. During 2017, the tank was painted under Contract 46W. The tank was taken out of service in April 2017 and returned to service on July 20, 2017. The rectifier for the cathodic protection system, which was not replaced with the remainder of the system in 1998, was removed as part of Contract 46W. A 9' high security fence was also constructed around the tank during 2017. In 2018, an anniversary inspection was conducted by MBA prior to the end of the Contract 46W maintenance period. A few minor punch list items were noted by the inspection and subsequently addressed by the contractor. In 2019, some growth on the exterior of the tank was noted; however, the tank coating still appears to be in good condition.

2.4 MG Tank  
Growth observed during 2019 Inspection

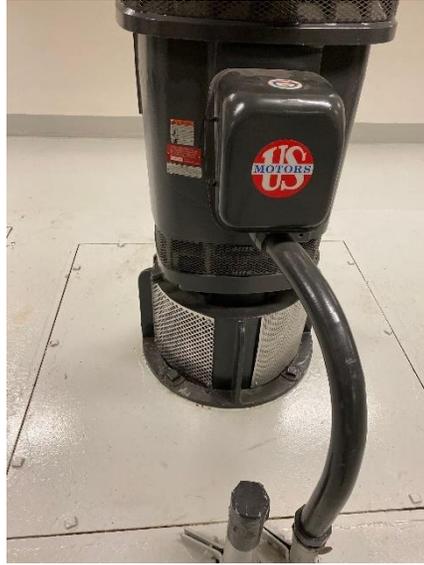
- HMUA personnel replaced the impeller and shaft sleeve for Raw Sewage Pump No. 3 in April 2011. The pump bearings and suction cover wear ring for this pump were also replaced by the HMUA in August 2011. . During 2011, the HMUA investigated pump noise and bearing temperature concerns for Raw Sewage Pump No. 3; however, a report by Rapid Pump and Meter in November 2011 found the pump to be operating within limits and the pump was returned to service.
- Raw Sewage Pump No. 1 was replaced in December 2012.
- In 2016, HMUA personnel replaced the rotating assembly for Pump No. 3.
- Raw Sewage Pump No. 2 was rebuilt in 2017
- Following a 2018 safety inspection, HMUA added shields below the motors where the pump shafts are exposed.

Raw Sewage Pump Motor with shield

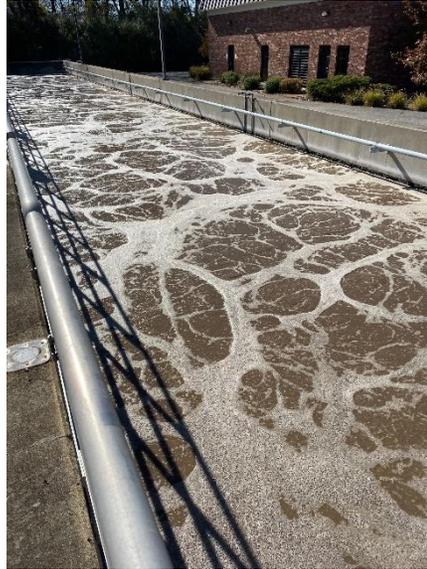
During 2011 and 2012, the HMUA inspected and cleaned all diffusers in both Nitrification Tanks. The cleaning of the diffusers reduced the operating pressure for the aeration blowers. The effluent end diffusers have been removed from one tank as a trial operation. In 2017, Mott MacDonald carried out an evaluation of options for diffuser replacement as the existing swing-

arm mechanisms are no longer manufactured, and other diffuser designs offer higher efficiency. HMUA completed Contract 48S which included diffuser and mixer replacement in July 2019.

Nitrification Tanks with New Diffusers
